VEHICLE INSPECTION REPORT

PO70YBF

FIAT DUCATO 35 2.3 MULTIJET 140PS

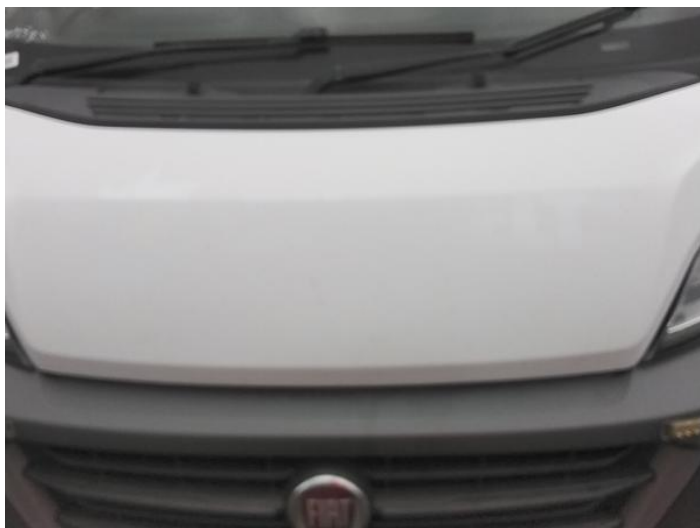
1: Bonnet
Chipped
Multiple Chips

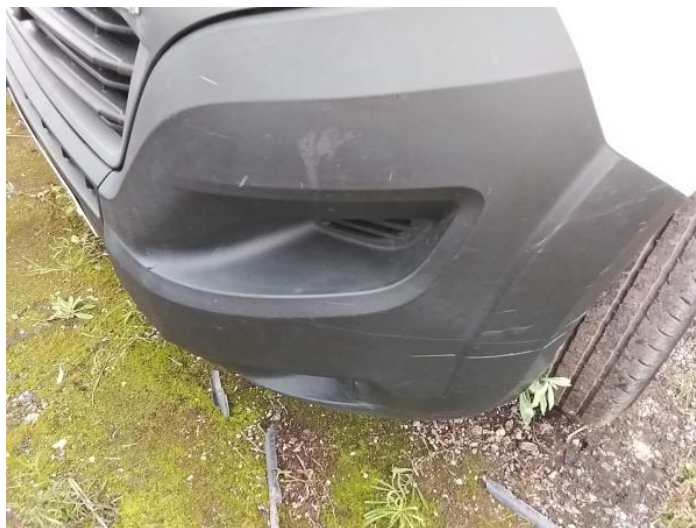
2: Bumper Front
Scratched
Over 100mm Thru Paint

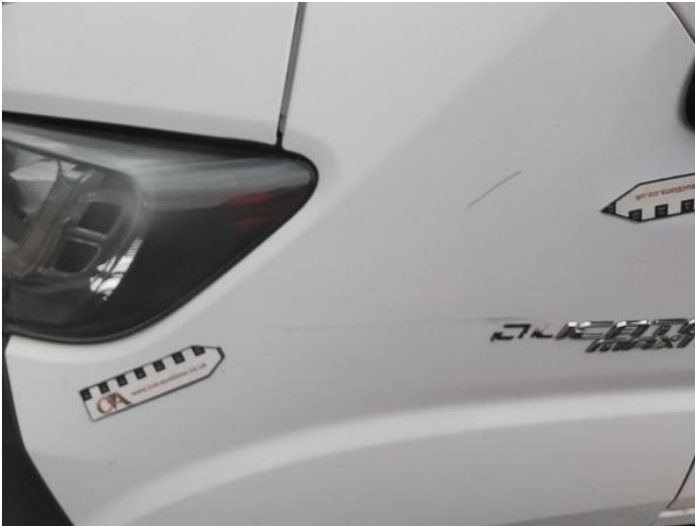
3: Wing nsf
Scratched
Over 25mm Thru Paint

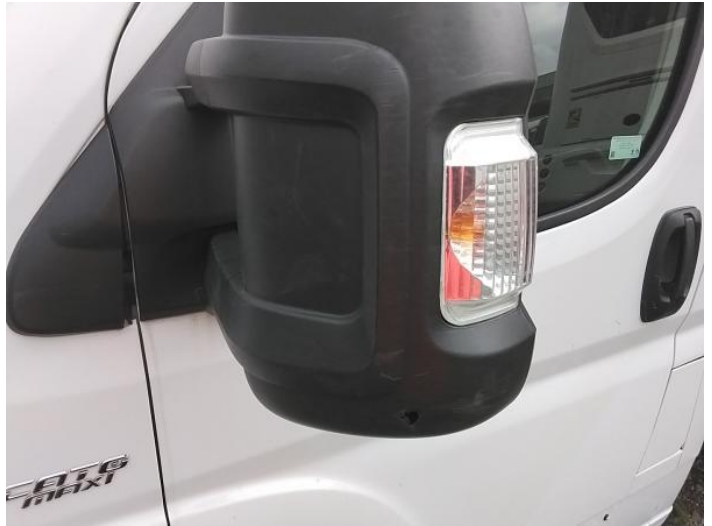
4: Door Mirror Assy nsf
Broken
Replace

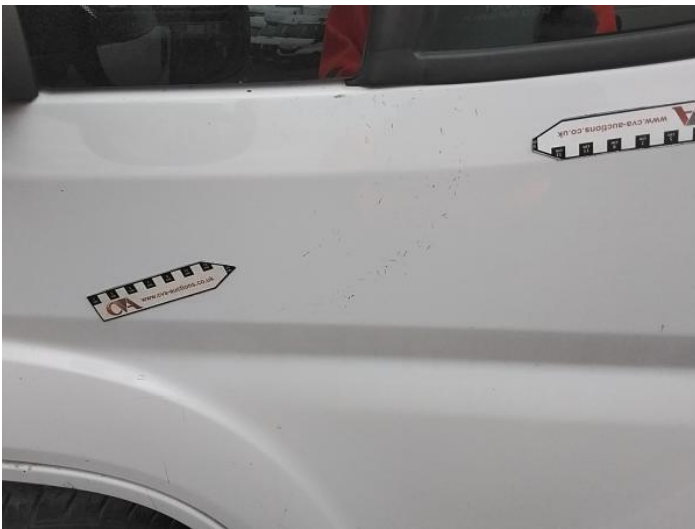
5: Door nsf
Scratched
Over 25mm Thru Paint

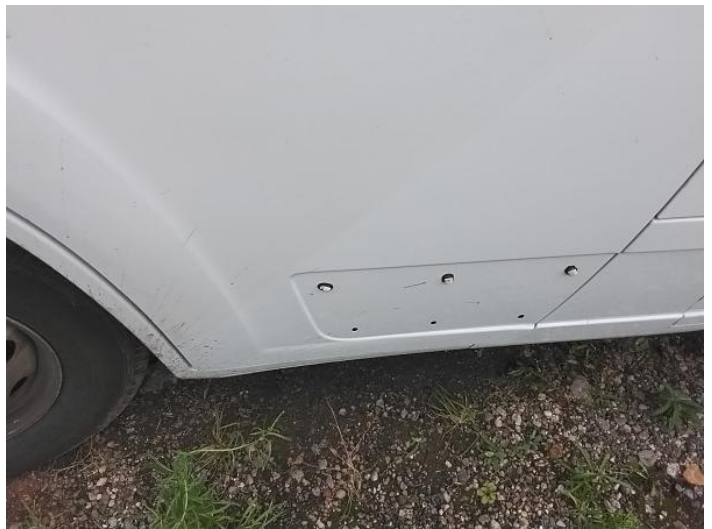
6: Door Moulding nsf
Missing
Replace

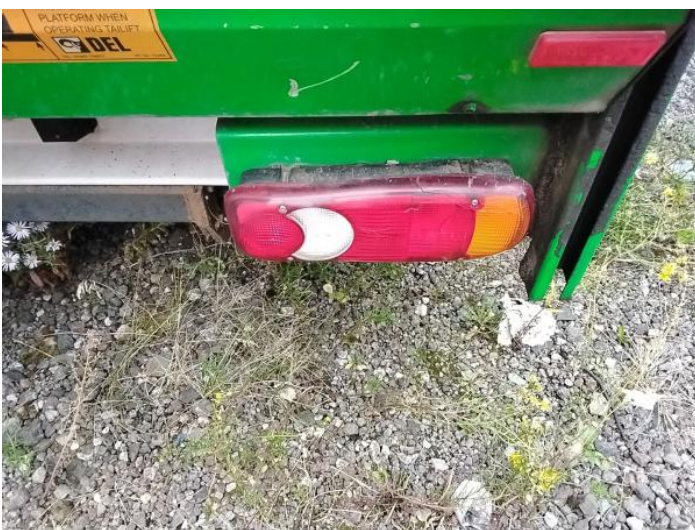
7: Lamp osr
Broken
Replace

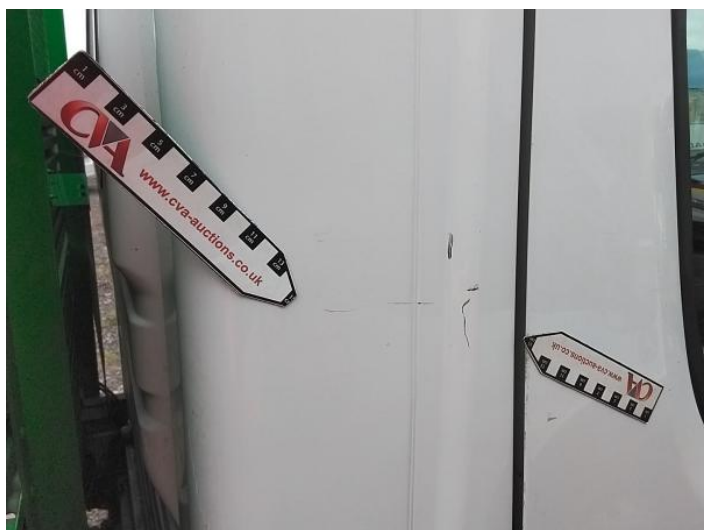
8: B Post os
Scratched
Over 25mm Thru Paint

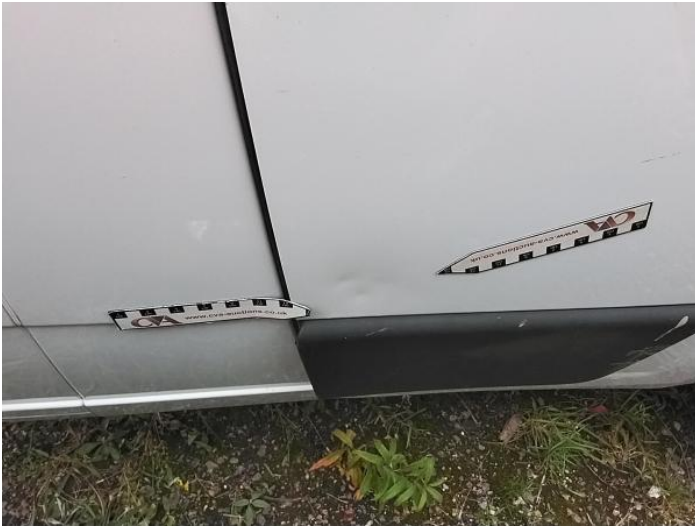
9: Door osf
Dented
Over 30mm

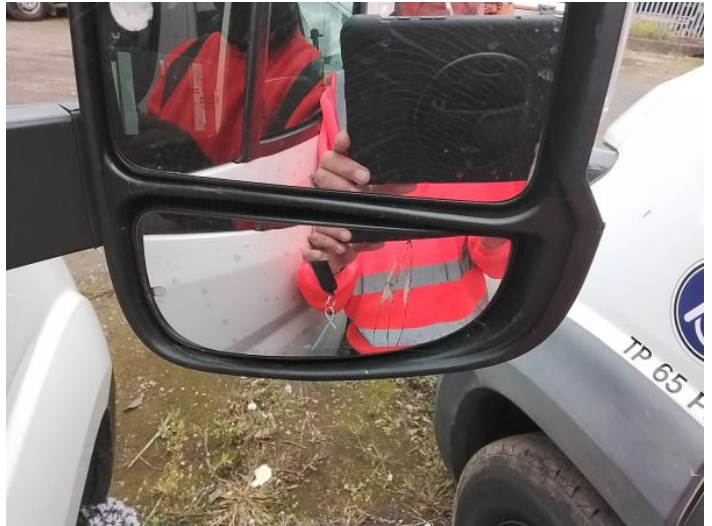
10: Door Mirror Glass os
Broken
Replace

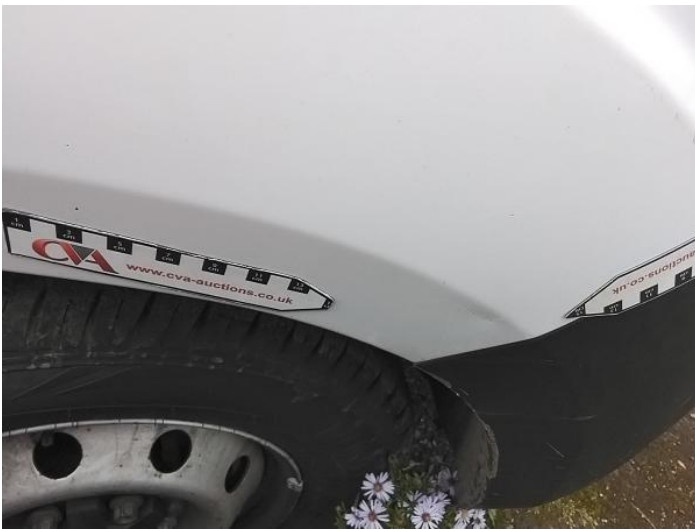
11: Wing osf
Dented
With Paint Damage

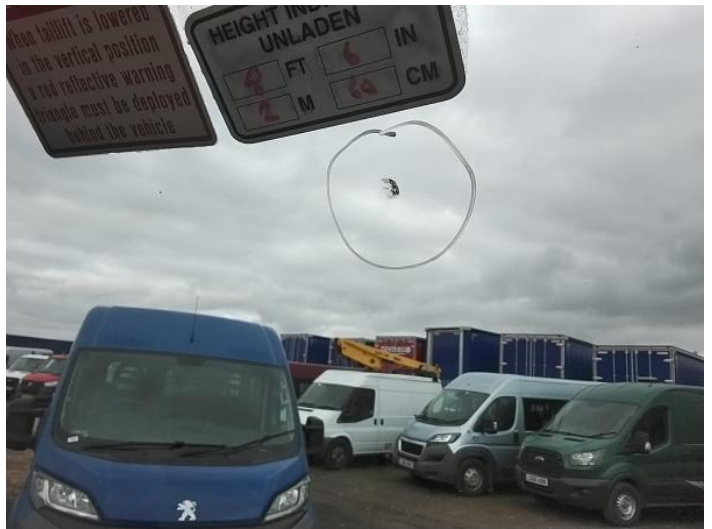
12: Screen Front
Chipped
Over 10mm

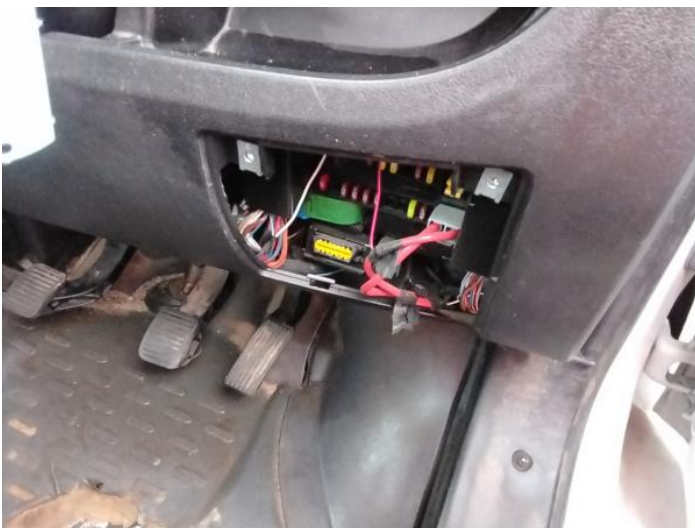
13: Fascia Panel
Missing
Replace

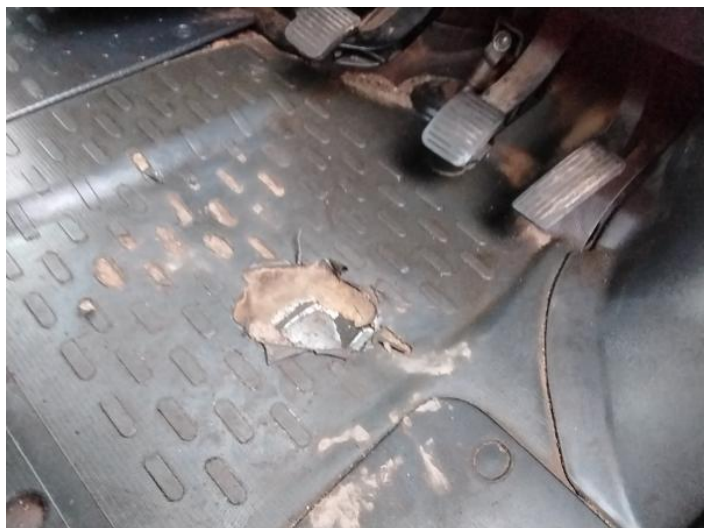
14: Carpets Front
Holed
Over 3mm
